AAIB Special Bulletin S6/2013, published on 5 September 2013, provided initial information on the circumstances of the accident. This bulletin provides an update on the significant investigation findings to date.

History of the flight

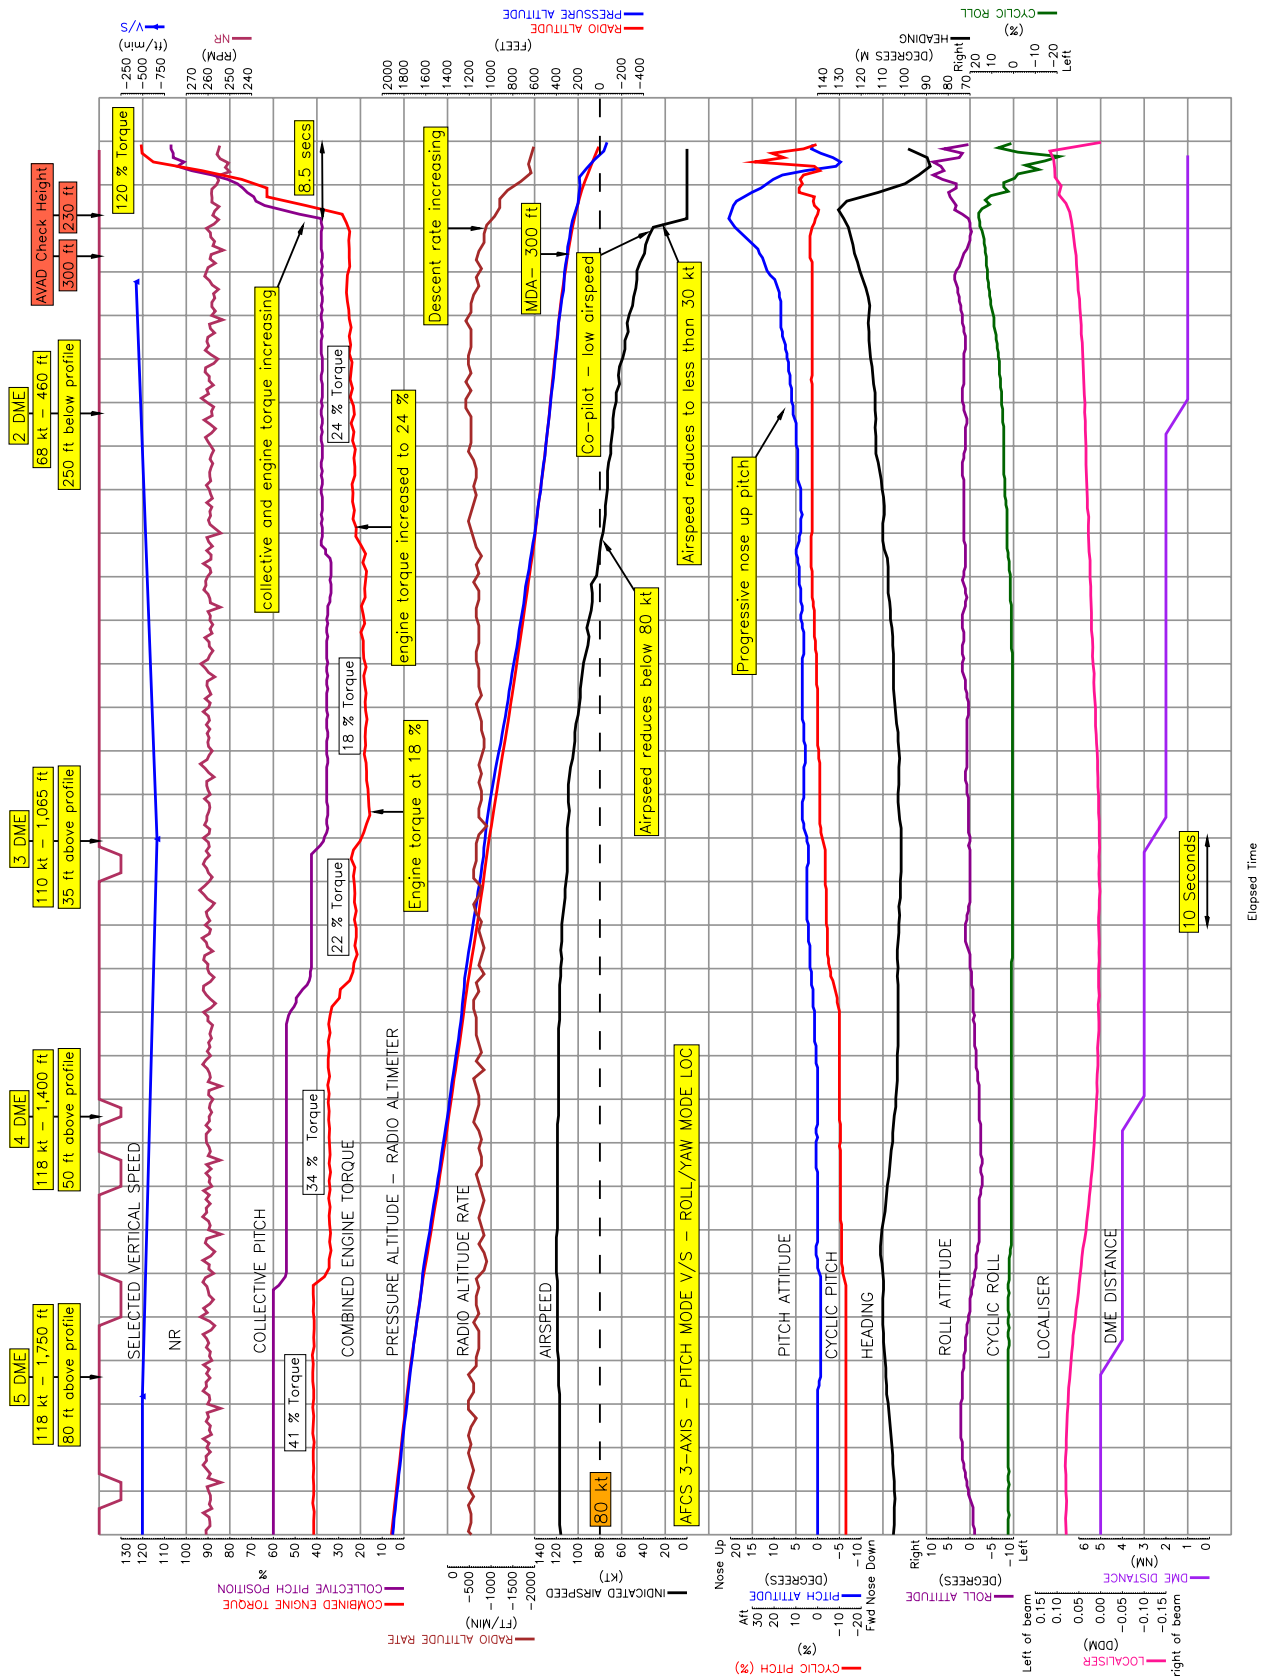
Figure 1 presents the salient recorded data for the final approach to Runway 09.

Recorded data parameters for the Final Approach

At 3 nm, the collective pitch was reduced and the engine torque stabilised at 18%. The airspeed was reducing at a rate of about 1 kt per second.

At approximately 2.6 nm and an altitude of 800 ft, the co-pilot advised they had 500 ft to go to the MDA, which the commander acknowledged. The airspeed was 87 kt and the descent rate was about 700 ft/min. When the airspeed reached 80 kt the collective pitch was increased, with an accompanying increase in engine torque to 24%.

At 2.2 nm, the helicopter was at an altitude of 560 ft and the airspeed was 74 kt. The helicopter's pitch attitude started to increase slowly as the autopilot maintained the selected vertical speed, whilst the airspeed continued to decrease.

With the co-pilot having advised that the target altitude at 1 nm was 390 ft, the commander stated that he was reducing the rate of descent; the rate reduced from about 700 ft/min to about 500 ft/min. Several seconds later, the co-pilot advised they had 100 ft to go to their MDA and the commander acknowledged. The descent rate was being maintained at about 500 ft/min, but the airspeed had by then decreased to 54 kt and the pitch attitude was 8° nose-up with engine torque stabilised at about 24%.

The AVAD aural "CHECK HEIGHT" function activated at a height of 300 ft above the sea. The airspeed had reduced to 43 kt and the pitch attitude was now 12° nose-up. The co-pilot alerted the commander to the airspeed.

At a height of 240 ft, the helicopter's pitch attitude was 20° nose up, the airspeed 32 kt and the rate of descent about 1,000 ft/min and increasing. There was then an increase in collective pitch and engine torque and the cyclic stick was moved forward. A second AVAD "CHECK HEIGHT" callout occurred at this time. The helicopter was at 230 ft and the airspeed had reduced to below 30 kt (airspeeds of less than 30 kt are not recorded on the CVFDR).

In response to the increase in collective pitch, engine torque increased at a rate of about 14% per second. The helicopter's descent rate nevertheless continued to increase. As it descended through 100 ft, the AVAD 100 ft call was recorded. Engine torque was now at 115% and the descent rate was approximately 1,800 ft/min.

This initial analysis also showed that the combination of the nose-high attitude, low airspeed, high rate of descent and high power placed the helicopter in a vortex-ring state⁷ entry condition (VRS) during the final stages of

the flight. The manufacturer's modelling indicated that, in this condition, the reduced helicopter performance, together with the limited height available, meant that the impact with the sea was unavoidable.
